## Town of East Troy 2022 Road Program Base Patching Summary:

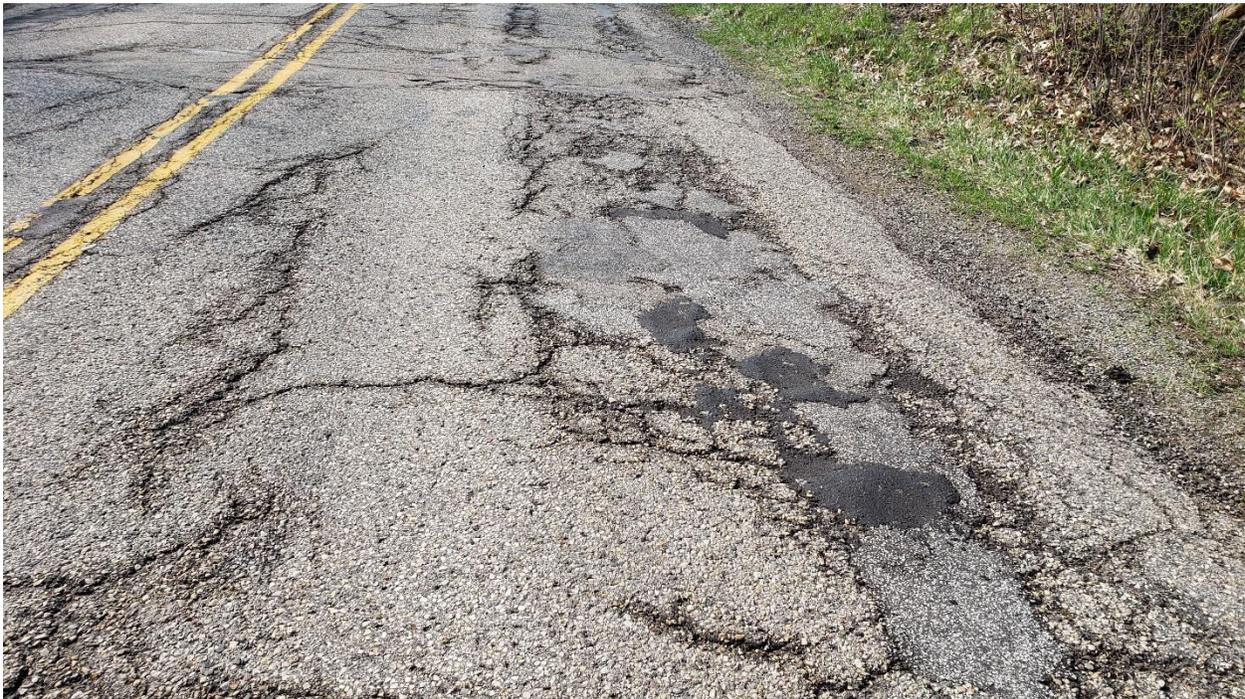
This process started with evaluating the worst areas for correction. Here was a typical area where base pavement correction was required.

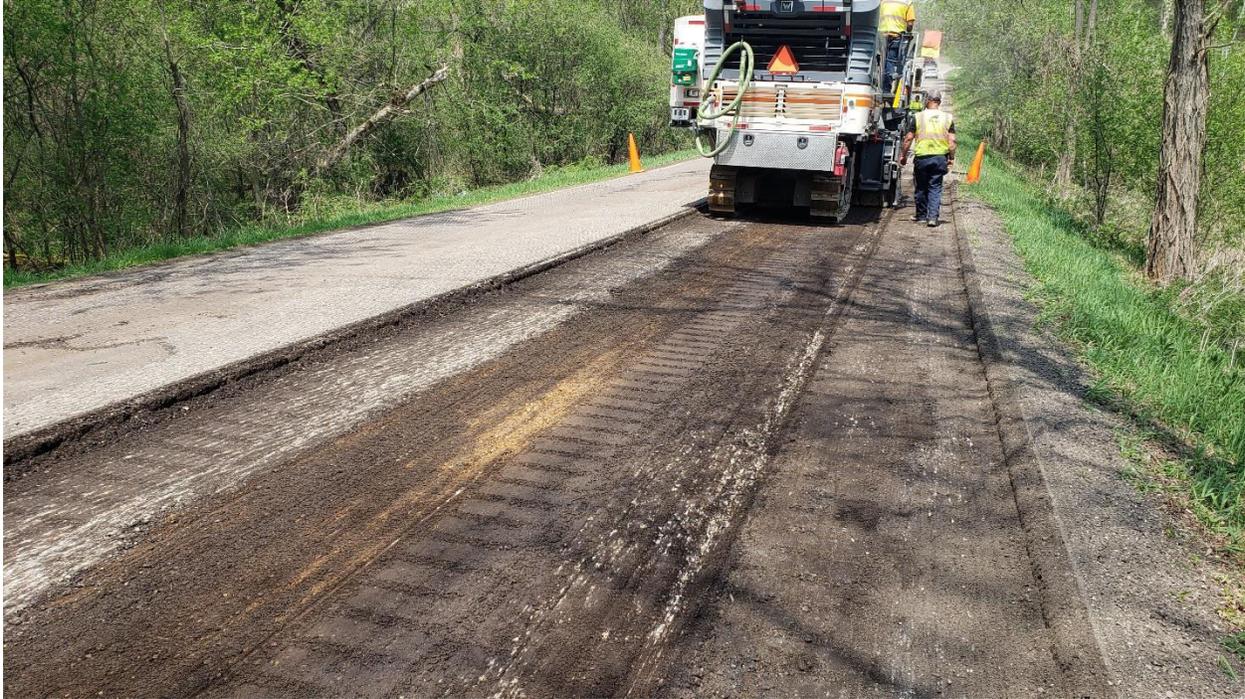
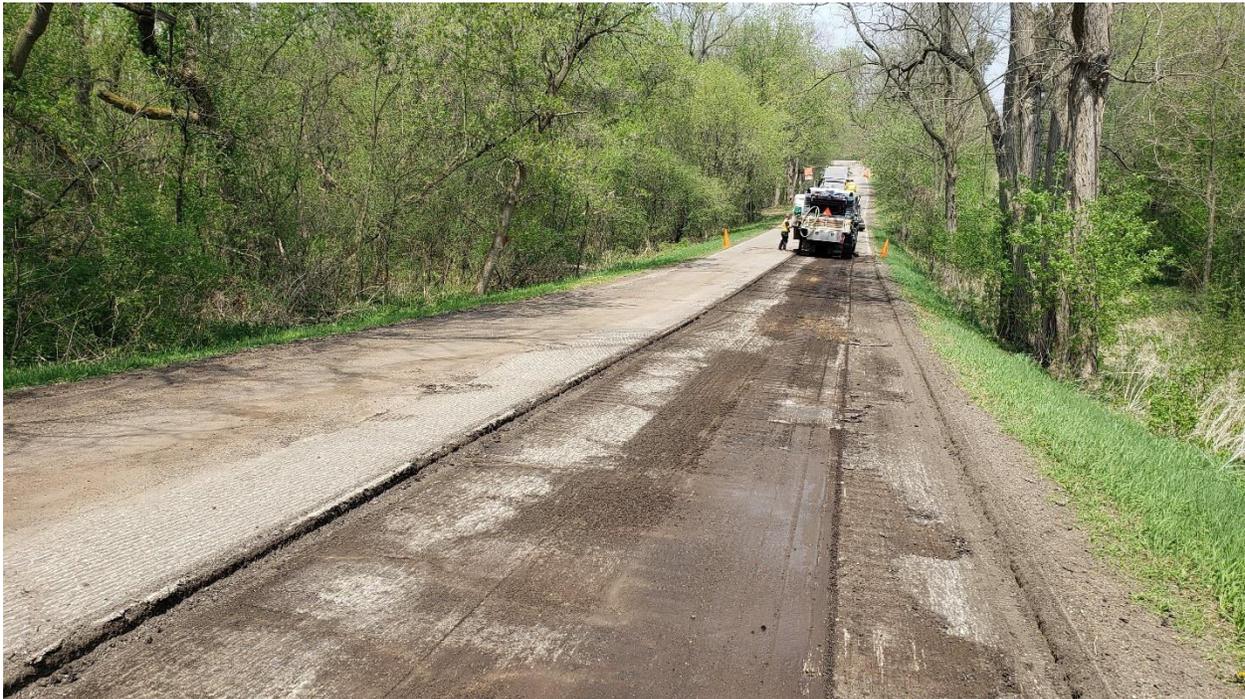
The correction process starts with utilizing a pavement milling machine in which we extracted 4" of the compromised pavement and exported from site.

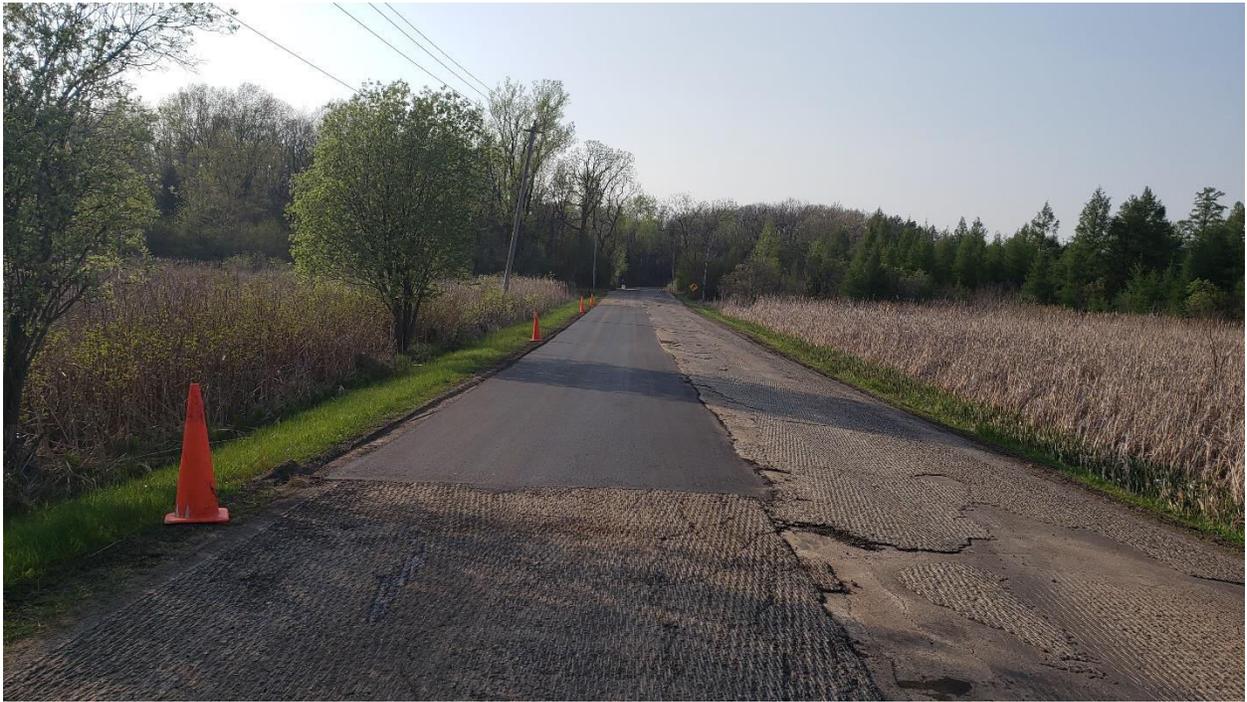
The base stone is then recompact and 4" of HMA binder is placed to match the existing pavement elevation ready for resurfacing as shown here. This work was performed with a special mobilization the day before to allow for the binder patching to cool and cure overnight.

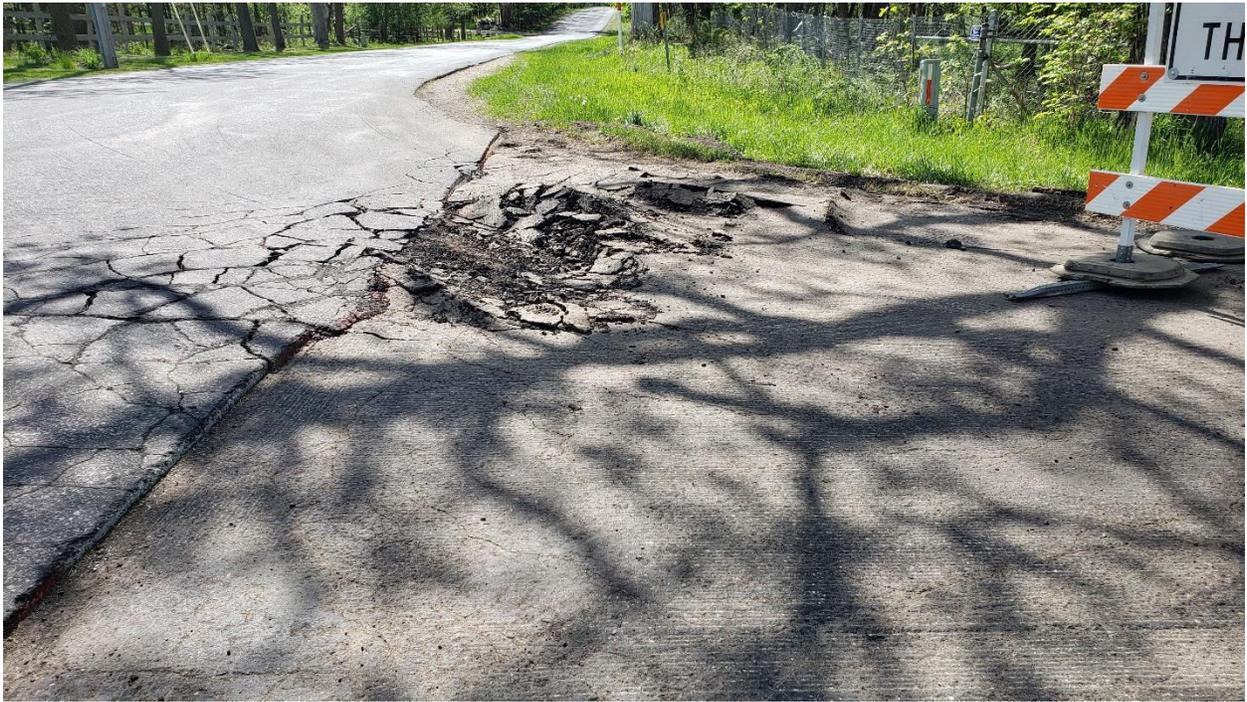
Unfortunately, there was another area that didn't look distressed until the loaded trucks drove over it which caused an emergency repair to be performed in order to keep paving as shown here.

It was found that there was only 3” of aggregate base below this pavement and then 3’ of extremely soft silty clay. This excavation was performed by the Town DPW forces. Stark Pavement assisted with placing and compacting the base stone and installation of a thick binder base patch to bridge the soft material. To make things more difficult, there was a high-pressure gas main running directly in the middle of the patch.

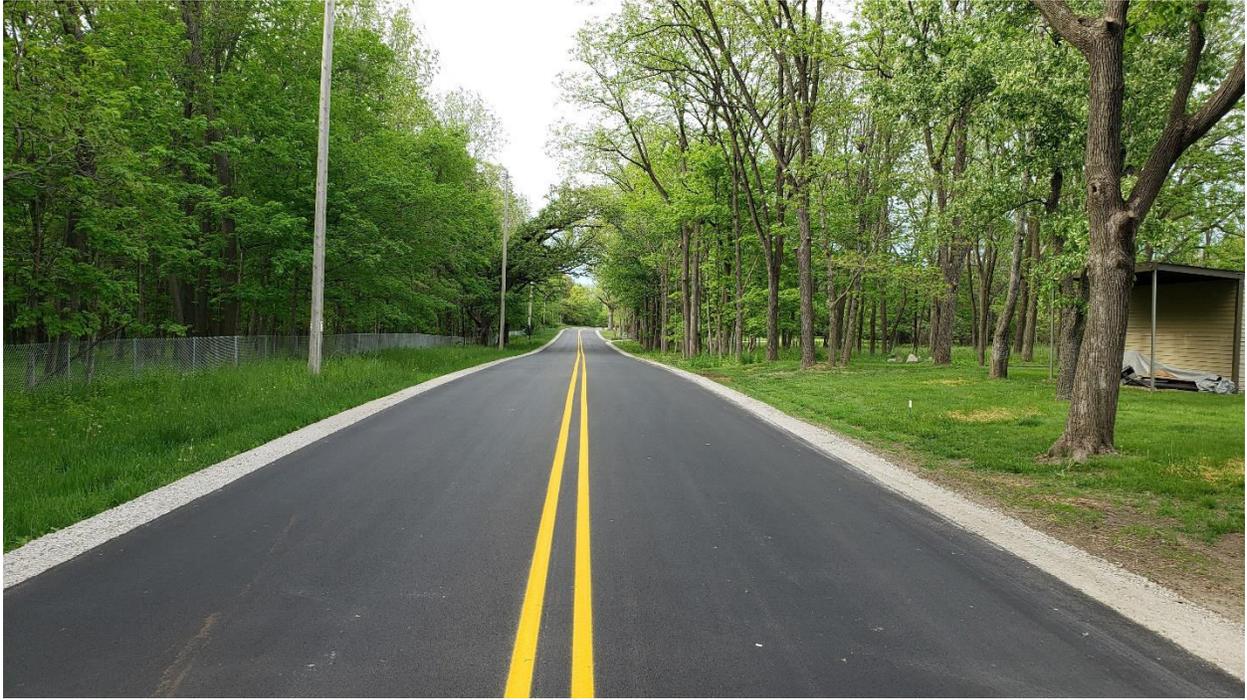
Upon completion of the binder base patching, the roads were paved, shouldered, and striped as anticipated with the final results shown here.
